Preservation Briefs: 9

The Repair of Historic Wooden Windows

John H. Myers

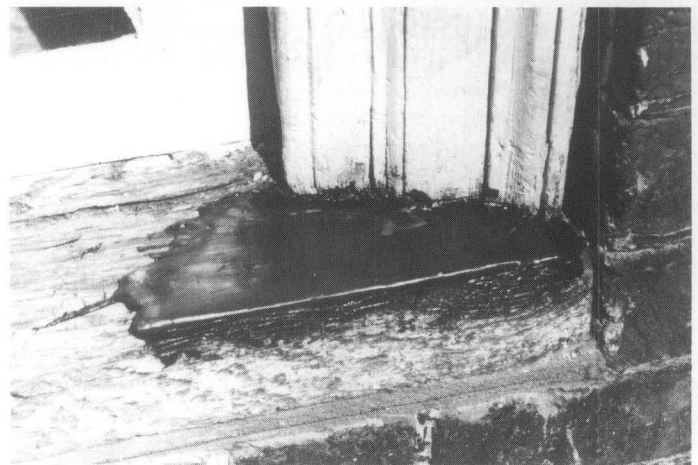
Figure 5. This illustrates a two-part epoxy patching compound used to fill the surface of a weathered sill and rebuild the missing edge. When the epoxy cures, it can be sanded smooth and painted to achieve a durable and waterproof repair. Photo: John H. Myers

Wood may also be strengthened and stabilized by consolidation, using semi-rigid epoxies which saturate the porous decayed wood and then harden. The surface of the consolidated wood can then be filled with a semi-rigid epoxy patching compound, sanded and painted (see figure 5). Epoxy patching compounds can be used to build up
