NATIONAL
TRUST
FOR
HISTORIC
PRESERVATION®

Repair or Replace Old Windows

A Visual Look at the Impacts

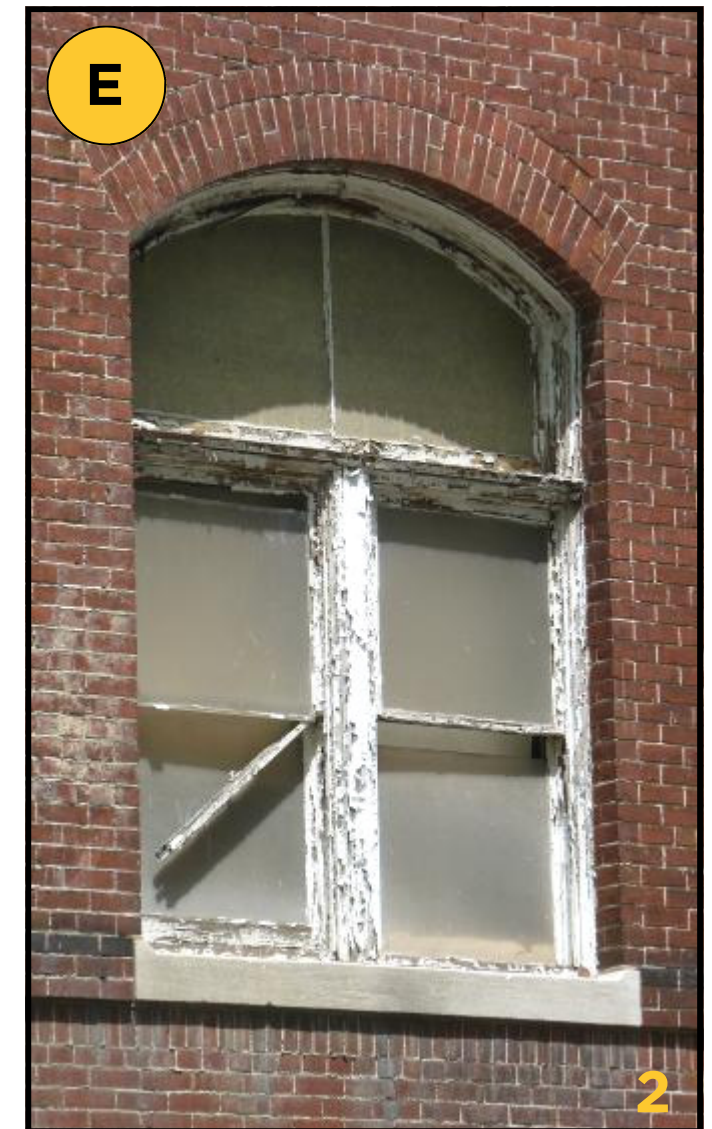
- A Six-over-six double-hung sash with loose meeting rail, missing glass — can be repaired.
- B Queen Anne windows needing paint, re-glazing — can be repaired.
- C Two-over-two double-hung sash with loose bottom rail, needing paint, re-glazing — can be repaired.
- D Arched double-hung sash windows missing glass and frames — replacement likely.
- E One-over-one double-hung sash windows and fixed transoms with detached meeting rail, needing paint and re-glazing — can be repaired.
- F Queen Anne window in poor condition, detached from frame and missing glass — borderline, requiring extensive repairs.
- G Queen Anne window missing glass and subject to structural settling of the building — borderline, requiring extensive repairs.

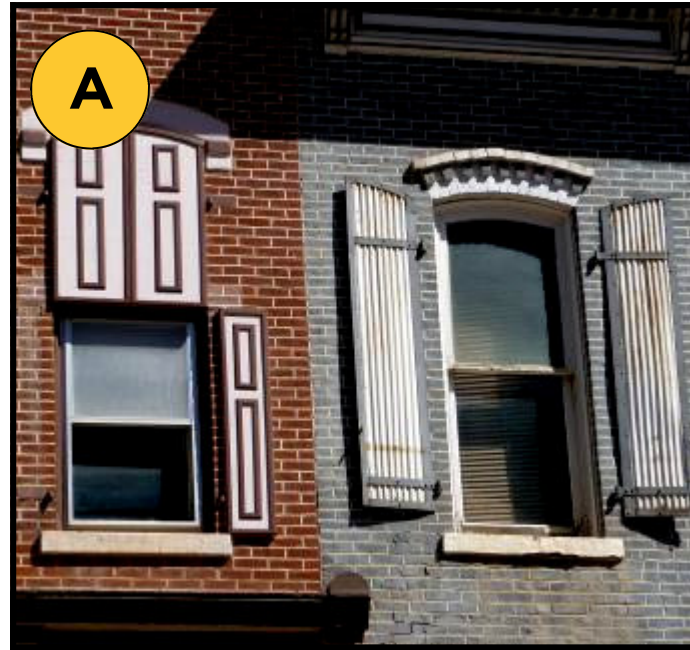
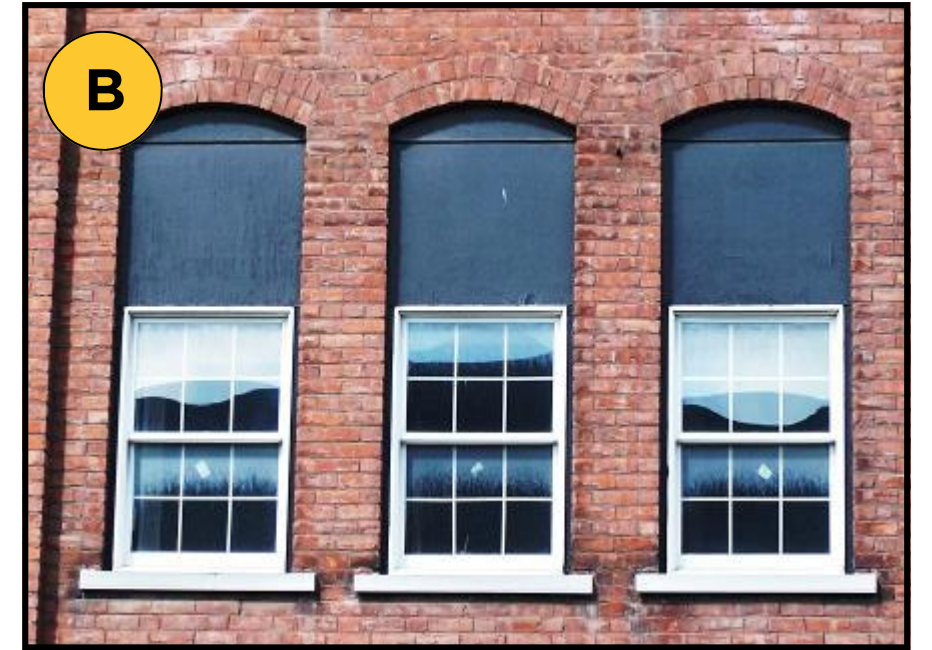
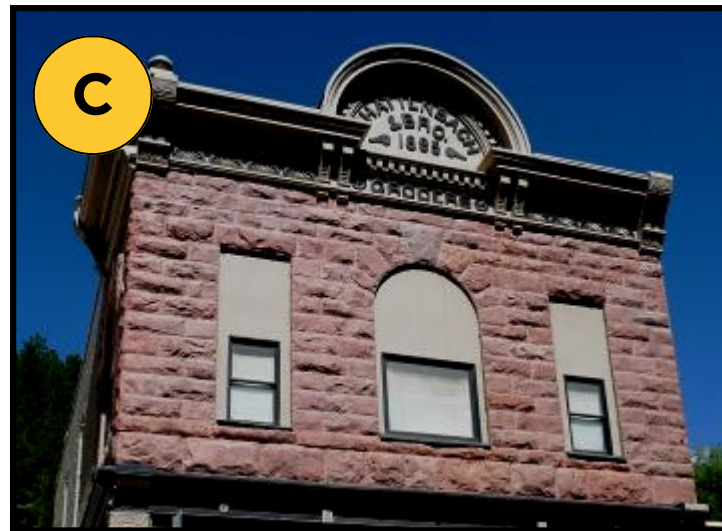
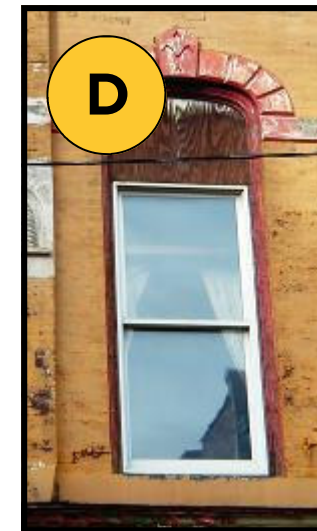
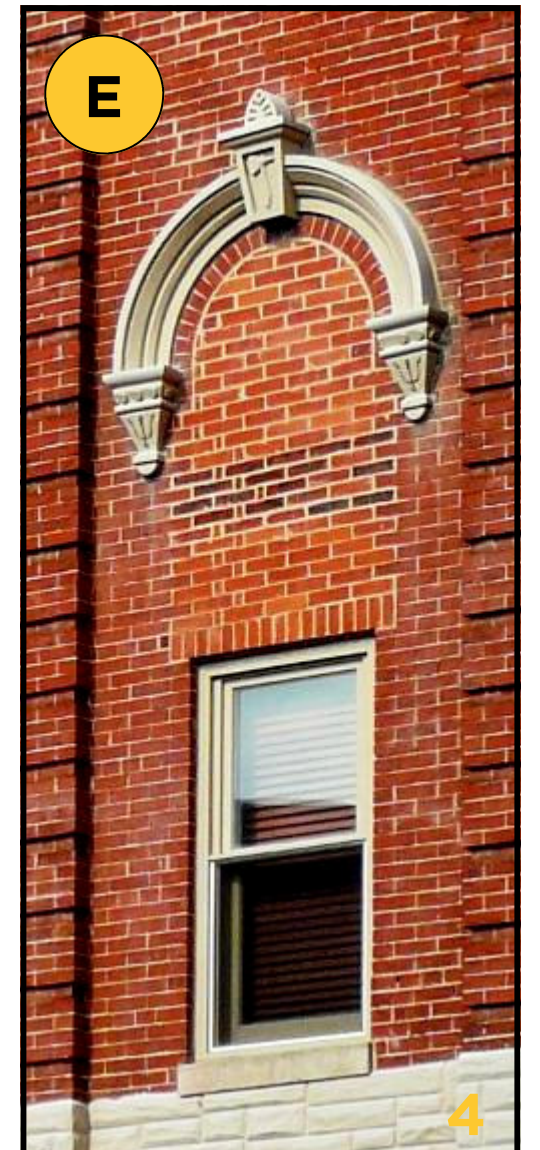
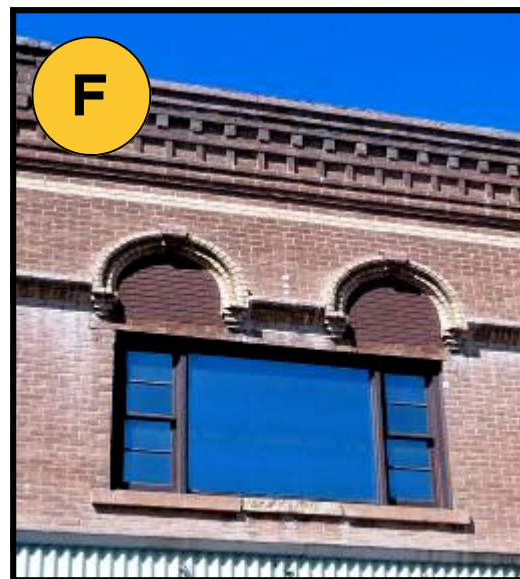
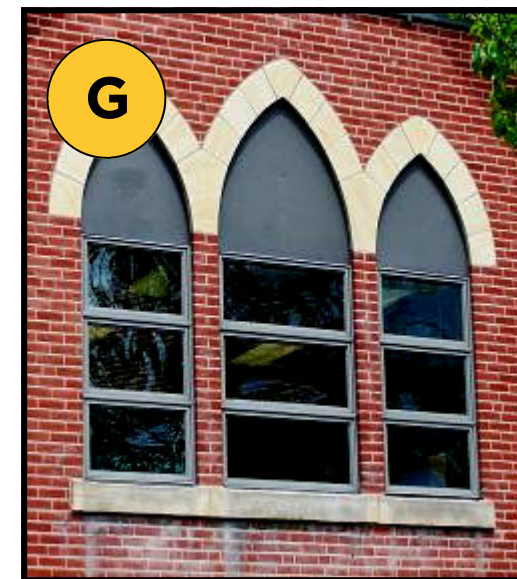
- A Italianate style row houses, side by side. Building to the right retains original arched one-over-one double-hung sash windows. Building to the left has smaller replacement windows and in-fill panels installed in the original opening.

- B Industrial building converted for housing with reduced windows and in-fill openings.
- C Main Street commercial building with upper floor windows removed, openings reduced down and much smaller replacement windows that do not match.

- D A stock, smaller window unit was used to replace a larger double-hung sash window.
- E Brick was used to in-fill the original opening of the round-arched window.

- F Two round arched windows were removed and replaced by one larger picture window, completely different in design and period to the historic Main Street building.

- G Three vertically-oriented Gothic style windows were reduced and replaced by horizontally-oriented hopper type windows.

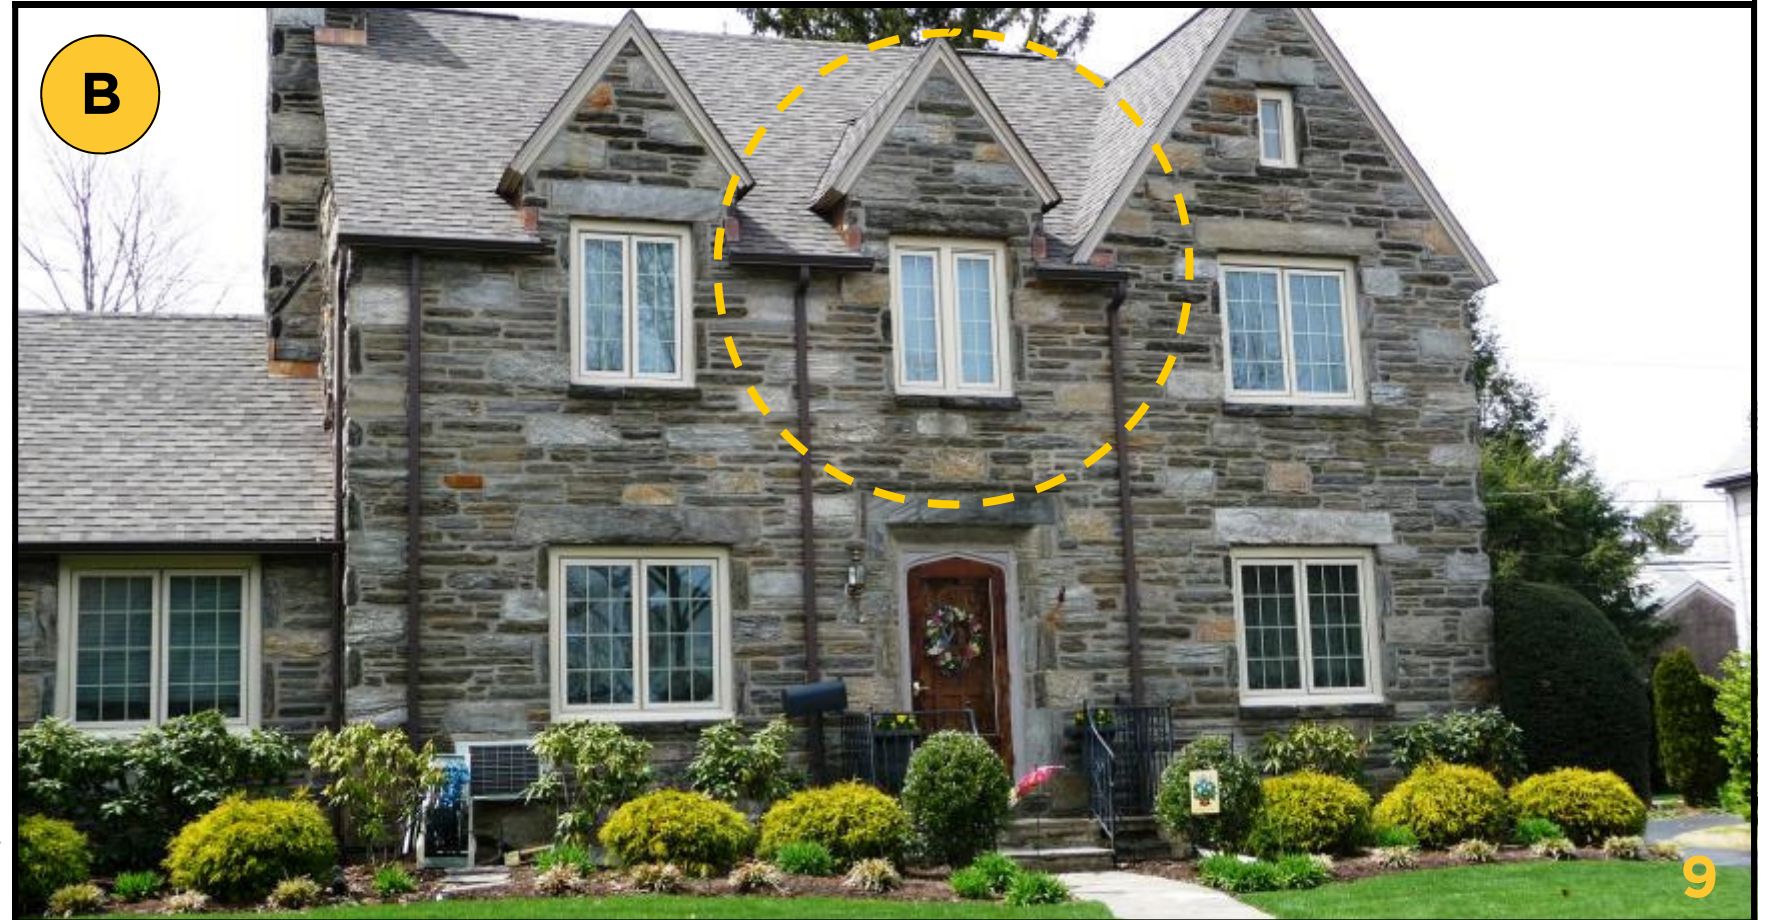
- A Steel casement windows with fixed transoms and side-lights, featuring interior storm windows. These windows are a character defining feature of the house.
- B Replacement windows attempt to match with casement style units yet the proportion, pattern, width and lack of a true divided-light miss the mark.
- C, D The differences between the original and replacement are readily seen, where the wider casing and surround are much prominent on the replacement windows.

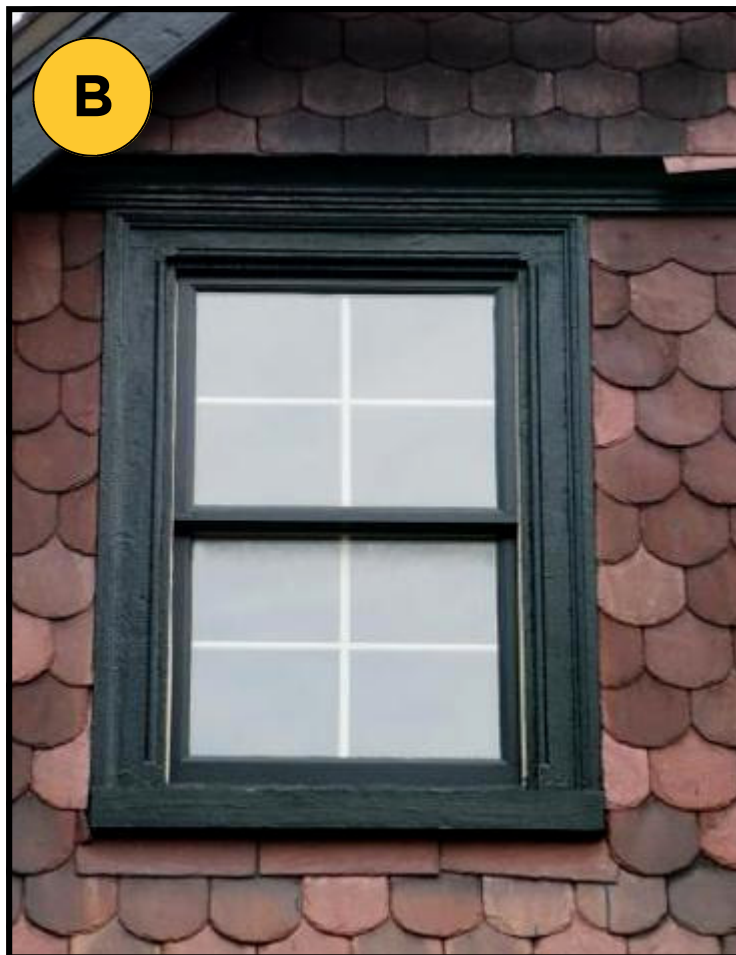
- A A former carriage house, rehabilitated and preserved for a new use, features replacement windows that attempt to look like true divided-light windows.
- B This four-over-four double-hung sash still has its original wood casing with a replacement window with clipped on interior muntins. There is little dimension or depth with this design and instead looks like a one-over-one sash.
- C This shows how clipped on interior muntins can loosen or fall off.

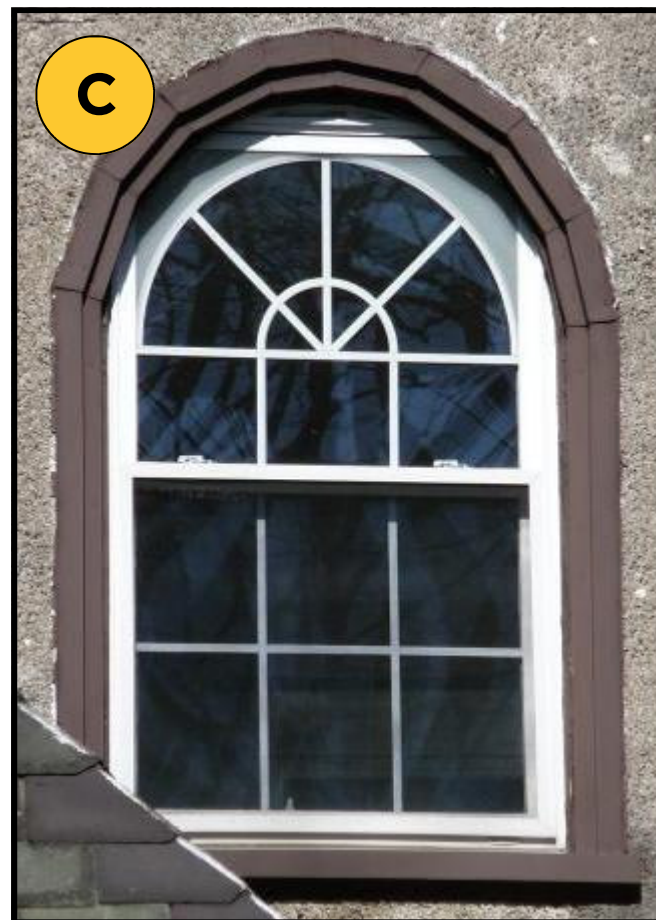
- A This eight-over-eight double-hung sash window with wood casing and sill is a common feature on houses in this neighborhood.
- B This replacement window attempts to replicate details of the original. However, it is not a true divided-light, the casing is wrapped in aluminum and the upper sash is flat and not round arched.
- C This replacement tries to look like a round arched window but is instead flat, features a completely different muntin pattern, has casing wrapped in aluminum and is not a true divided-light.

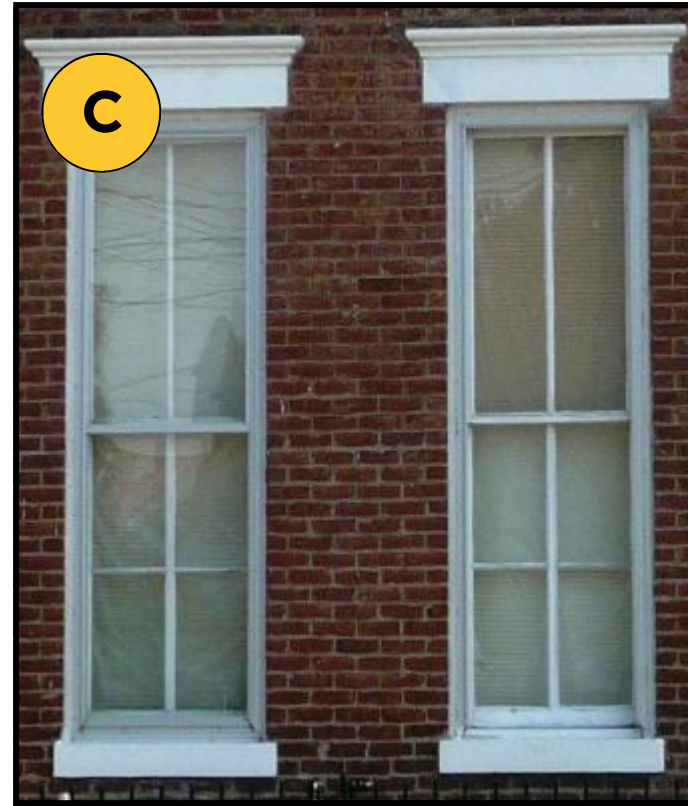
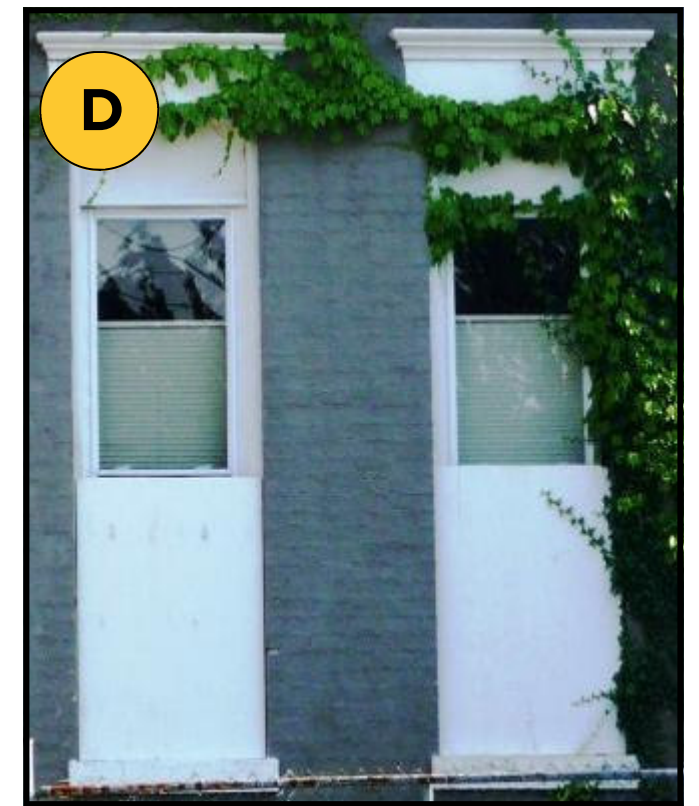
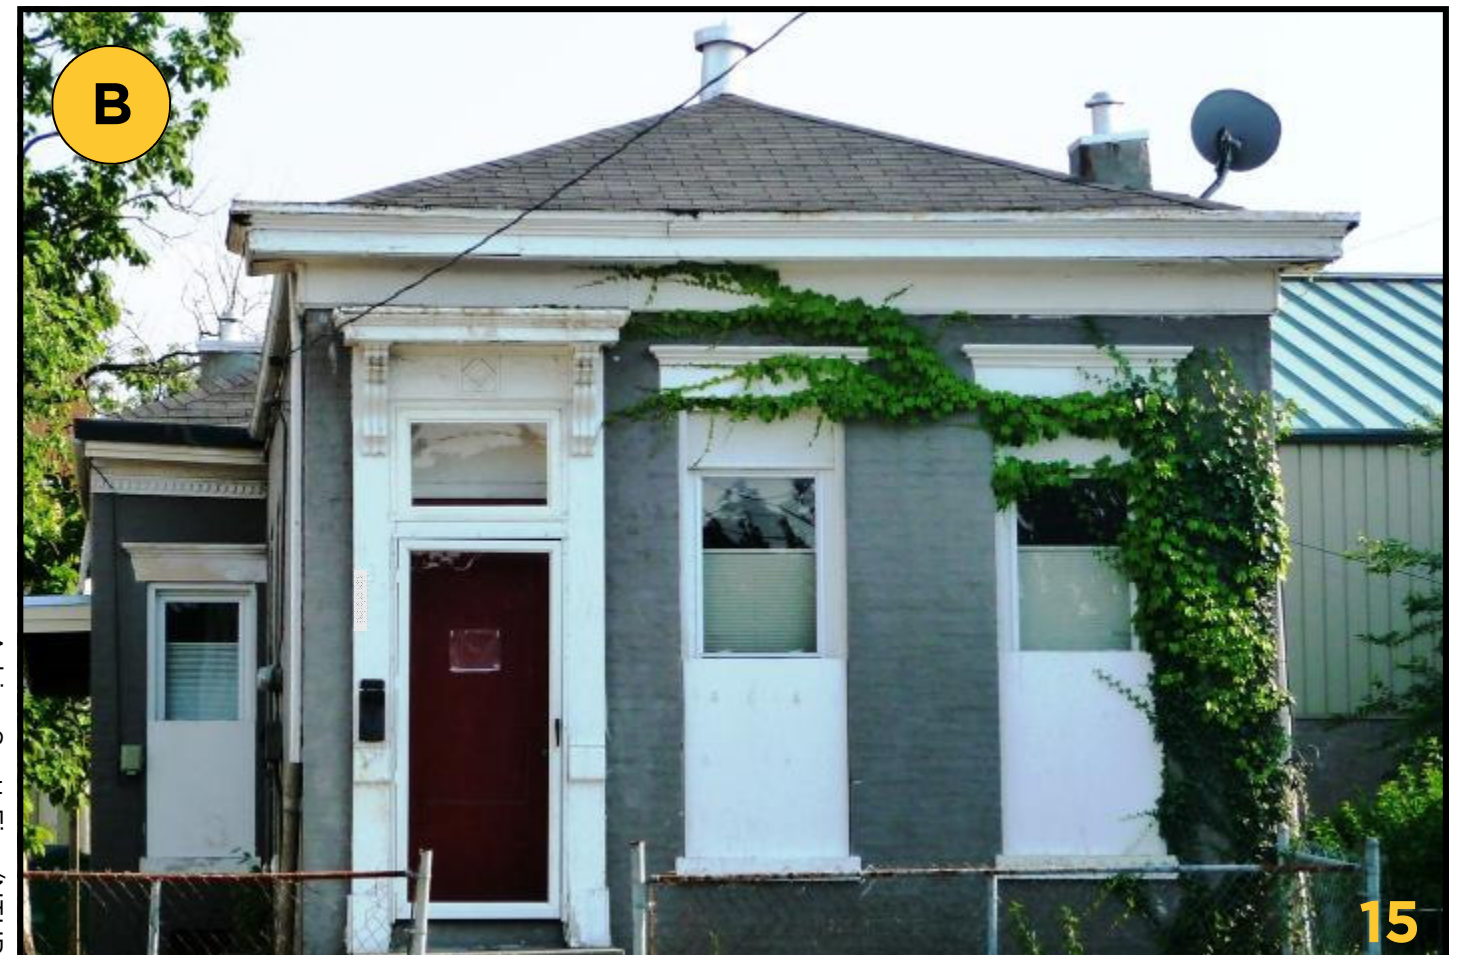
- A, B Two simple Shotgun style homes that were once nearly identical, to each other, and throughout the neighborhood.
- C Original two-over-two double-hung windows are a very prominent feature of these homes, directly relating to the size of the main entrance.
- D. The original windows were replaced, the openings reduced, and stock windows installed that are no longer in scale to the proportions of the house.
